S & B Services LLC
191 Candlewood Drive
North Kingstown, RI 02852
(401) 234-1283 Office
(401) 749-1151 Cell
NACHI06082890
Inspected By: Bruce Pinel

Inspection Date: 12/12/08
Report ID: JS123456

Date: 12/12/08	Time: 5:22 PM	Report ID: JS123456
Property: 123 Anywhere Lane Anytown, RI	Client: Joe Sample	Real Estate Professional:

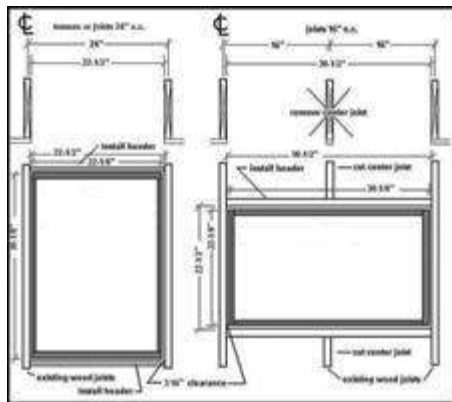
1.0 Picture 3

Attic access is located in the bedroom closet and is at least the recommended size of 22 inches by 30 inches.

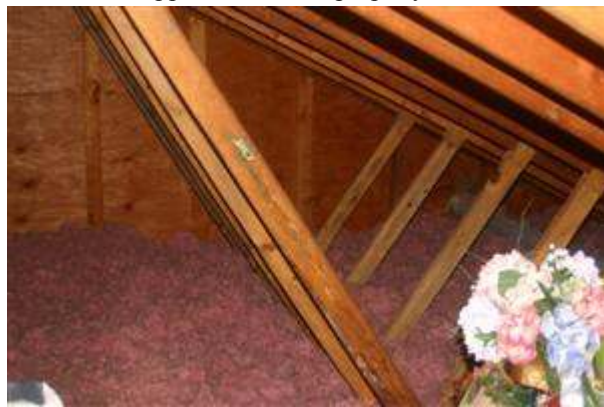
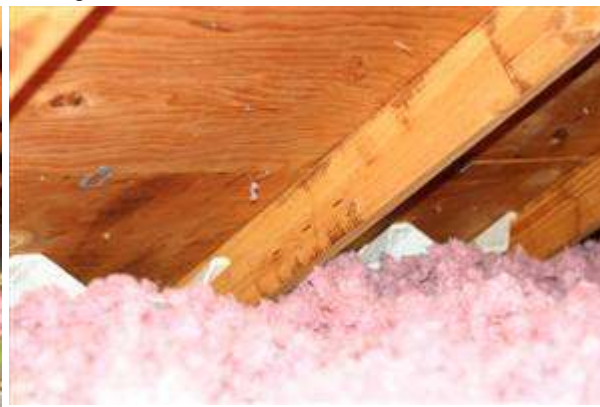
The attic floor has fiberglass (loose-fill) insulation and fiberglass (batt) insulation and is about 15 inches thick or around an R-49 value and appears installed properly. No further action is required at this time.

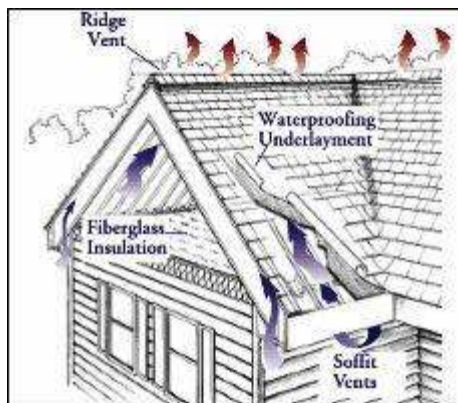
1.2 Picture 1

Proper attic ventilation prolongs roofing material life by providing for proper exhausting of moisture in the winter and heat during the summer. Otherwise, premature failure of the roof shingles, formation of mold and damage to the roofing structure will occur. The minimum recommended rate is 1 square foot of ventilation per 300 square feet of attic space, (1:150 for new construction), with more than 50% at the soffits and less than 50% at the ridge, picture 1, using a baffled ridge vent, picture 2, to maximize the ventilation exhaust. Also required is the installation of attic chutes to allow proper circulation and to prevent ice dams, picture 3. Most shingle manufacturers will not allow a full warranty on an improperly vented attic. This is provided for information.

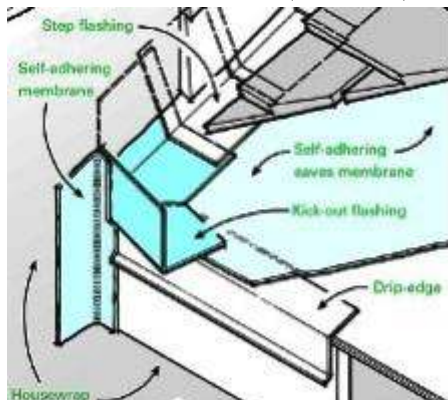
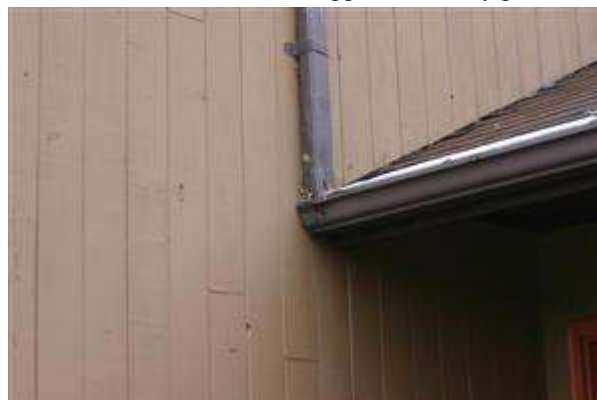
1.6 Picture 1

👉 "Kick out" flashing (Picture 1) should always be used when a roof line terminates midway on a vertical sidewall (Picture 2) to prevent water from entering behind the siding and rotting the sheathing. This should be repaired by a competent contractor to prevent moisture intrusion into the wall, eventually leading to rot and mold. This is an indication that the roofing and/or siding installation was not done by a professional contractor and may in fact affect the shingle warranty and/or siding quality. I recommend having a reputable, registered contractor make repairs so the proper gap exists between the siding and the roofing below and ensure the step flashing is installed properly. I recommend repairs and replacement as required by a Rhode Island registered roofing contractor.

"Kick out" flashing (Picture 1) should always be used when a roof line terminates midway on a vertical sidewall (Picture 2) to prevent water from entering behind the siding and rotting the sheathing. This should be repaired by a competent contractor to prevent moisture intrusion into the wall, eventually leading to rot and mold. This is an indication that the roofing and/or siding installation was not done by a professional contractor and may in fact affect the shingle warranty and/or siding quality. I recommend having a reputable, registered contractor make repairs so the proper gap exists between the siding and the roofing below and ensure the step flashing is installed properly. I recommend repairs and replacement as required by a Rhode Island registered roofing contractor.

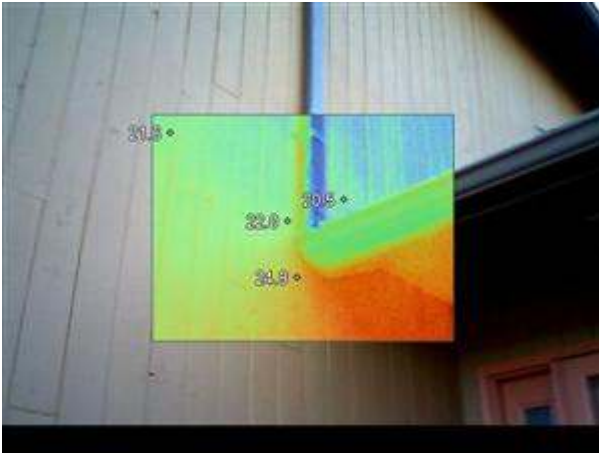
1.6 Picture 3

A thermo-scan of the area (Picture 3) was taken and there does not appear to be any problem at this time.

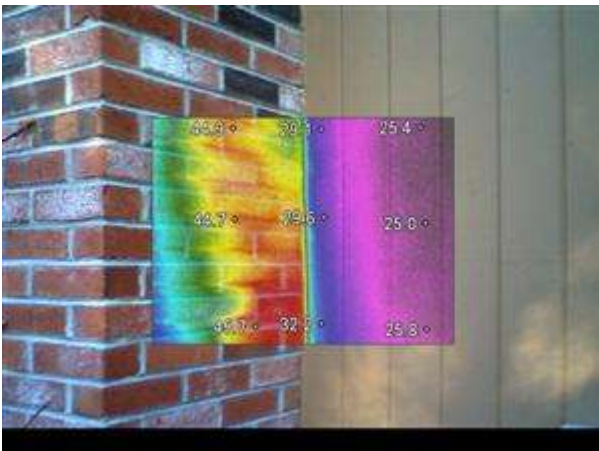
1.9 Picture 1

A thermo-scan of the chimney to house connection was taken and there does not appear to be any problem at this time. No further action is required at this time.

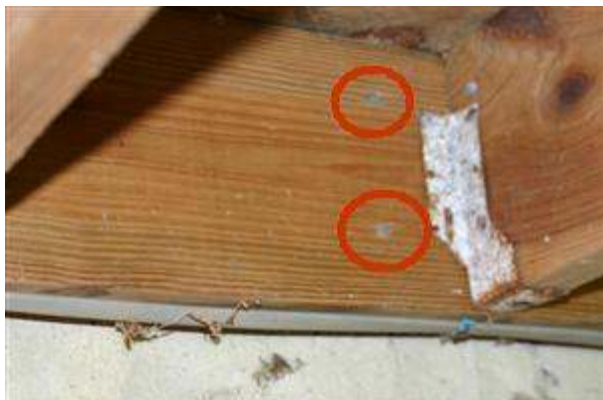
2.4 Picture 1

The deck ledger (Picture 1) is not attached properly to the structure of the home. To prevent a possible deck collapse as shown (Picture 2), it should have 1/2" galvanized "Lag or Thru Bolts" spaced accordingly depending on joist lengths (Picture 3) (Picture 4). Only RI registered contractors experienced in deck construction should be used to repair decks and related attachments.

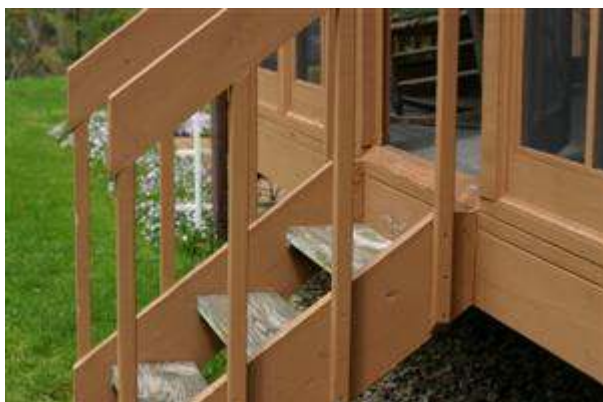
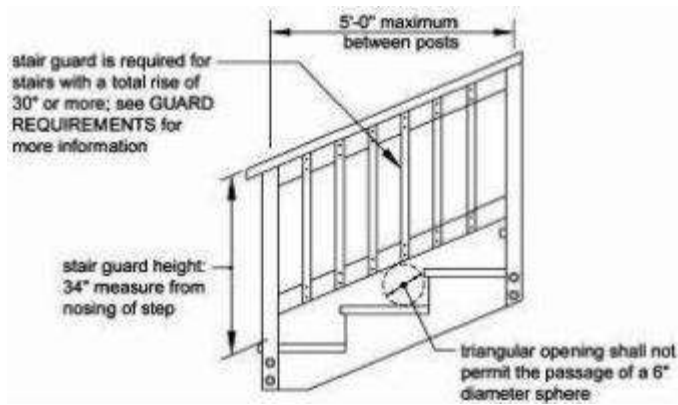
Handrails do not conform to today's standards of construction. Handrail height should be between 34 - 38 inches from the nosing of the tread. Spacing of guards (spindles), should be no more than a 4 inch sphere to preclude a child from passing through them. Only RI registered contractors experienced in deck construction should be used to repair decks and related attachments. This is provided for information.

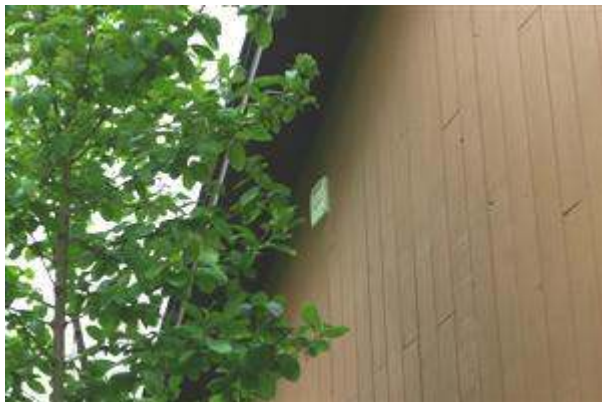
2.5 Picture 1

- 🏠 Vegetation needs to be trimmed back at least 12 inches from the house to prevent damage to the siding from moisture which will cause rot and mold formation and from providing a path to the home for insects.

Vegetation needs to be trimmed back at least 12 inches from the house to prevent damage to the siding from moisture which will cause rot and mold formation and from providing a path to the home for insects.

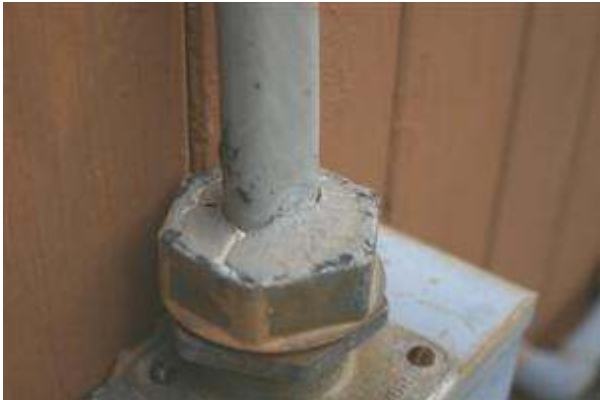
3.0 Picture 1

⚡ The duct seal around the service entrance cable (SEC) into the meter trim needs to be repaired by a licensed electrician to ensure the proper material is used and installed properly. An improper seal at this location can allow water to enter into the meter causing corrosion and a possible electrical failure.

The duct seal around the service entrance cable (SEC) into the meter trim needs to be repaired by a licensed electrician to ensure the proper material is used and installed properly. An improper seal at this location can allow water to enter into the meter causing corrosion and a possible electrical failure.

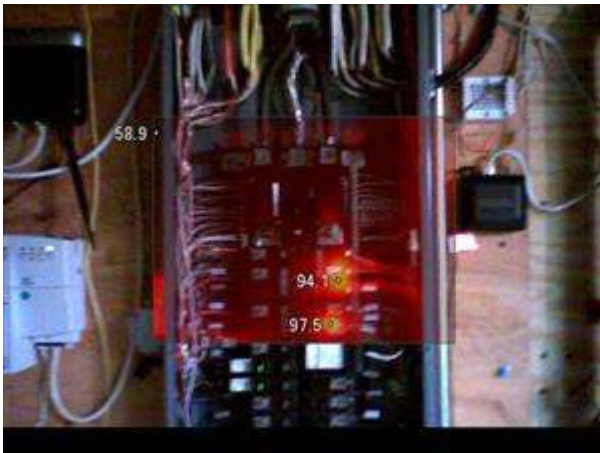
3.1 Picture 3

A thermo-scan of the electrical panel was taken and indicates that there is a temperature difference between the area in question (Picture 3) versus its surrounding area but the temperature is within the recommended range of the manufacturer. No further action is required at this time.

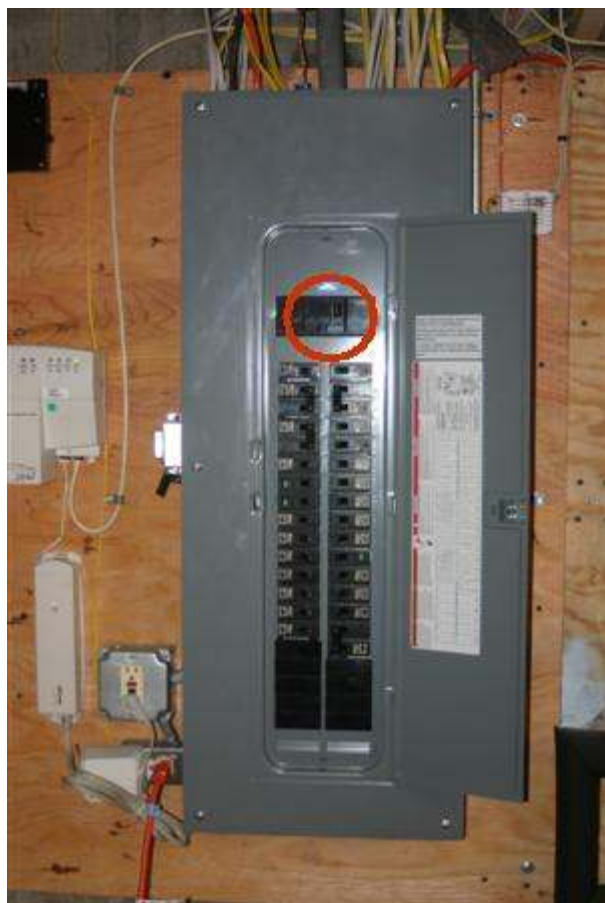
3.2 Picture 1

The main panelboard is located in the basement. The main disconnect (shut-off) for the panelboard is located at the panel (Picture 1).

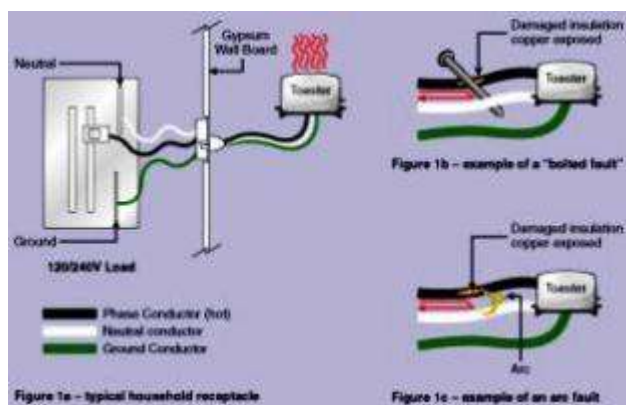
3.5 Picture 1

There are AFCI's located in the bedrooms. An arc-fault circuit interrupter is a device intended to provide protection from the effects of arc faults by recognizing characteristics unique to arcing and by functioning to de-energize the circuit when an arc fault is detected. They are now required in bedrooms for new construction. This is for information.

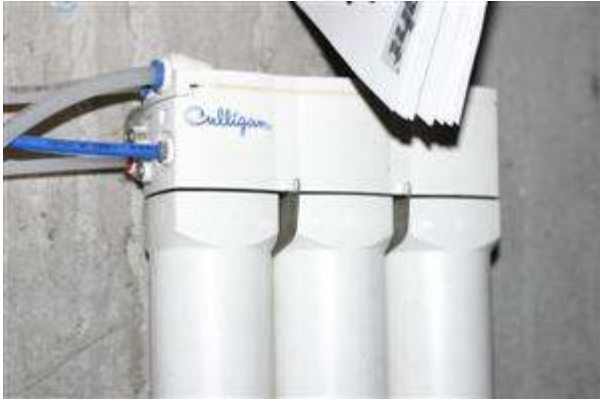
5.1 Picture 2

There is a "reverse osmosis" drinking water filtration system plumbed into the kitchen drinking water and refrigerator ice maker. These systems require yearly replacement of filters. The system was not inspected for functionality or performance. Familiarity with the manufacturer's service procedures by the homeowner or hiring a reputable contractor are highly recommended. This is provided for information only.

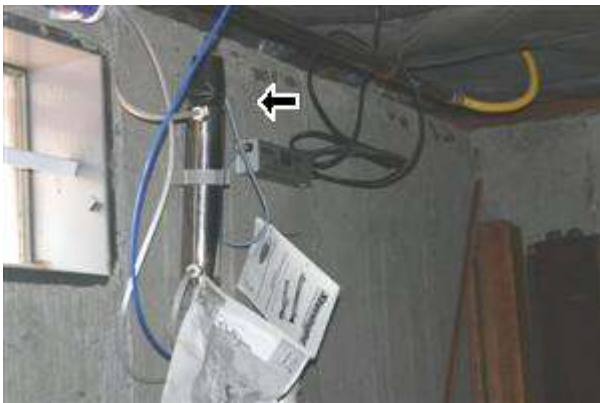
5.1 Picture 3

There is an "ultra-violet" disinfection system plumbed into the kitchen drinking water and refrigerator ice maker. These systems require yearly replacement of the UV bulb. The system was not inspected for functionality or performance. Familiarity with the manufacturer's service procedures by the homeowner or hiring a reputable contractor are highly recommended. This is provided for information only.

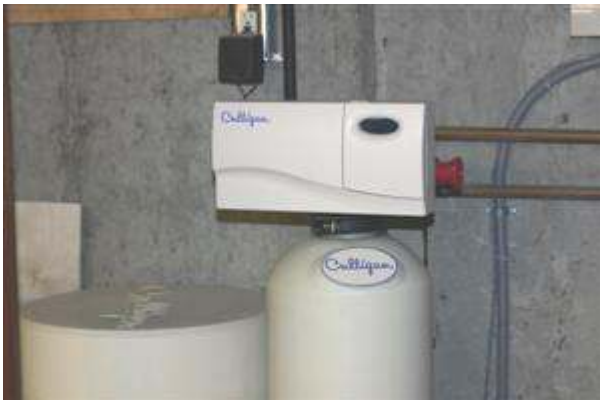
5.1 Picture 4

There is a "water softener" system plumbed into the water supply. These systems require regular adding of salt. The system was not inspected for functionality or performance. Familiarity with the manufacturer's service procedures by the homeowner or hiring a reputable contractor are highly recommended. This is provided for information only.

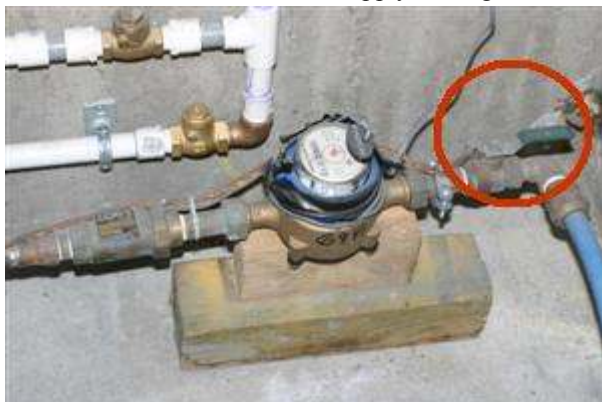
5.6 Picture 1

The main shut off for the water supply is the green lever located in the basement. This is for your information.

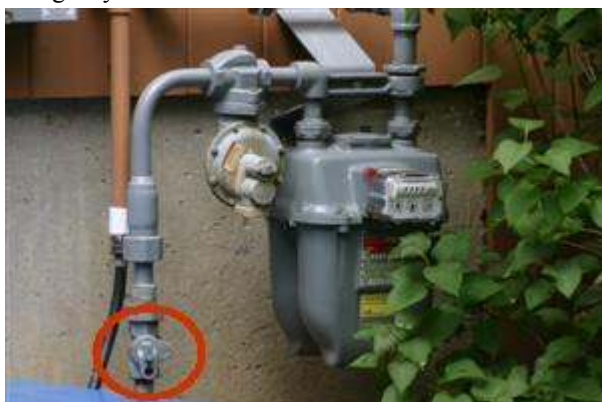
5.8 Picture 1

The main fuel shut-off for the natural gas is the gray lever at the gas meter. You should keep a wrench nearby in case of an emergency.

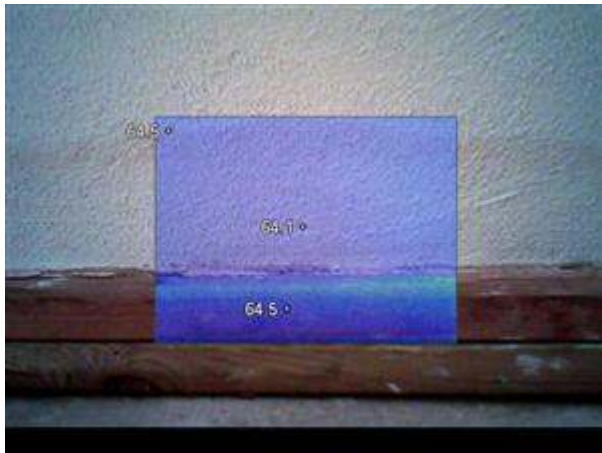
6.1 Picture 1

A thermo-scan of the of a possible leak internal to a wall was taken and and there does not appear to be any problem at this time. No further action is required at this time.

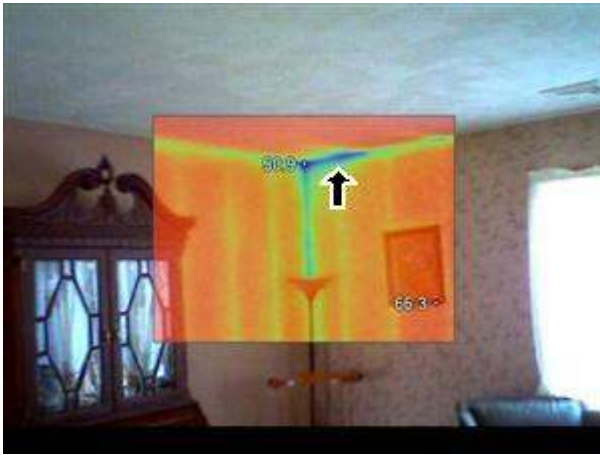
6.3 Picture 1

A thermo-scan of the of an exterior wall to evaluate the presence of insulation voids was taken and indicates that there is a temperature difference between the area in question versus its surrounding area which may indicate missing or settled insulation. A competent person should repair or replace as needed.

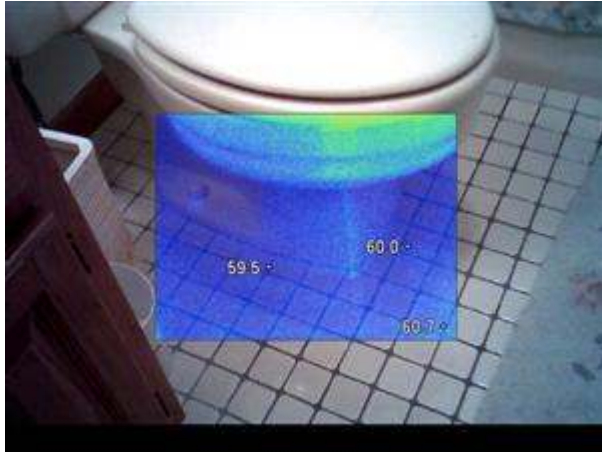
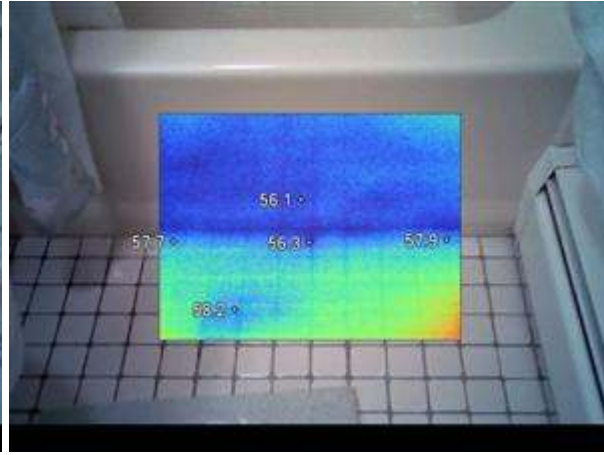
A thermo-scan of the bathroom toilet floor area and tub floor area was taken and there does not appear to be any problem at this time. No further action is required at this time.

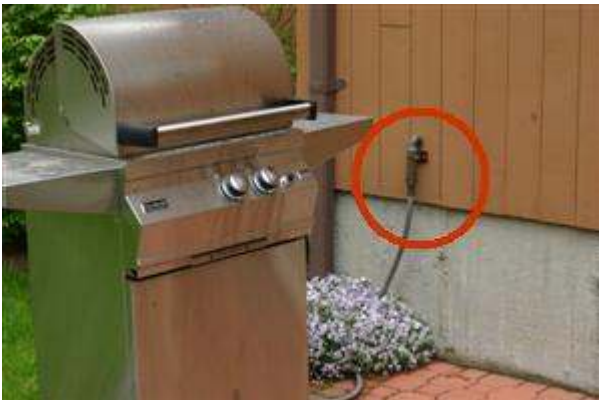
11.0 Picture 1

A natural gas line exists for an outdoor grill. If used, the grill burner needs to be certified for natural gas use. This is provided for information only.

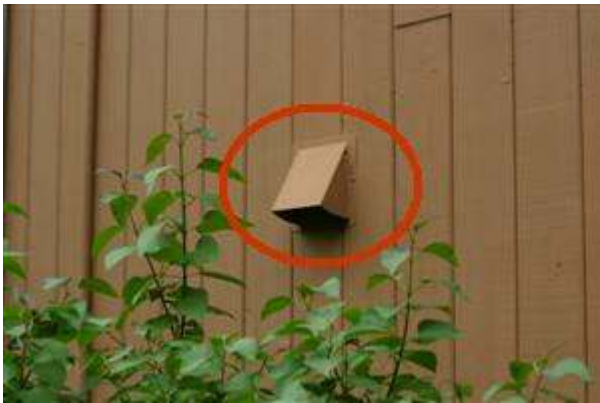
12.1 Picture 1

Central vac units should be exhausted to the outdoors whenever possible to reduce indoor contaminants and to reduce noise levels.
