S & B SERVICES LLC

ENERGY THERMAL SCAN

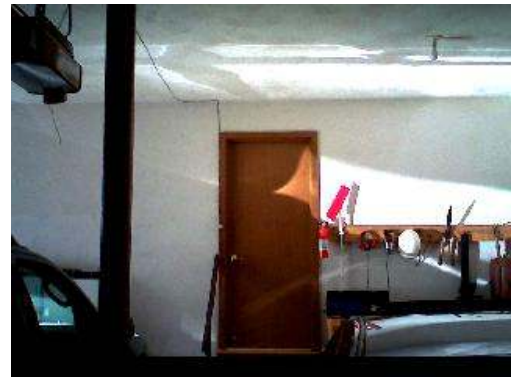
GARAGE DOOR.IS2

This is the door from the garage to the living area. There appears to be missing insulation on the upper half of the wall.

Image Range	47.2°F to 53.2°F
Camera Model	TiR
Camera Serial Number	TiR-08110392
Manufacturer	Fluke
Lens Description	20mm
Image Time	12/03/08 9:53:40 AM

Name	Temperature	Emissivity
Coldest	47.2°F	0.95
P0	51.9°F	0.95

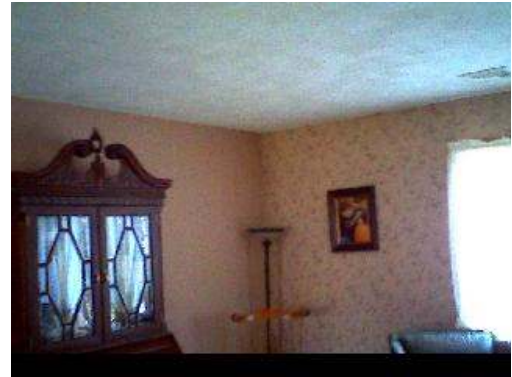
LIVING ROOM.IS2

This is the living room outside corner where the coldest areas are a result of structural framing members which are not insulated.

Image Range	50.9°F to 66.3°F
Camera Model	TiR
Camera Serial Number	TiR-08110392
Manufacturer	Fluke
Lens Description	20mm
Image Time	12/03/08 9:59:47 AM

Name	Temperature	Emissivity
Coldest	50.9°F	0.95
P1	63.2°F	0.95

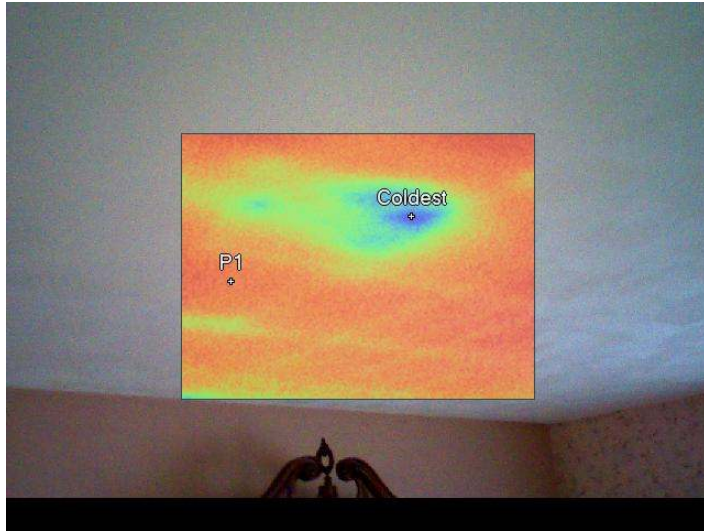
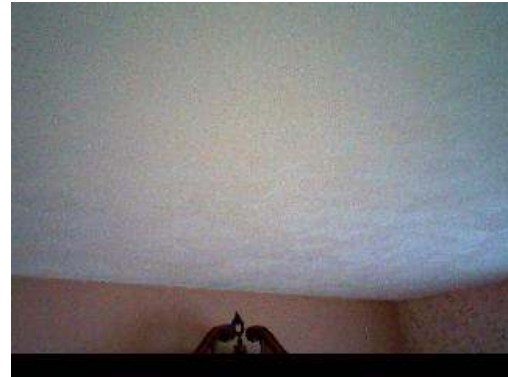
LIVING ROOM CEILING.IS2

This is the living room ceiling showing an insulation void.
(Moisture readings were taken to rule out moisture intrusion from either a roof leak or a compromise in the vapor barrier.)

Image Range	58.7°F to 66.7°F
Camera Model	TiR
Camera Serial Number	TiR-08110392
Manufacturer	Fluke
Lens Description	20mm
Image Time	12/03/08 10:00:00 AM

Name	Temperature	Emissivity
Coldest	58.7°F	0.95
P1	65.4°F	0.95

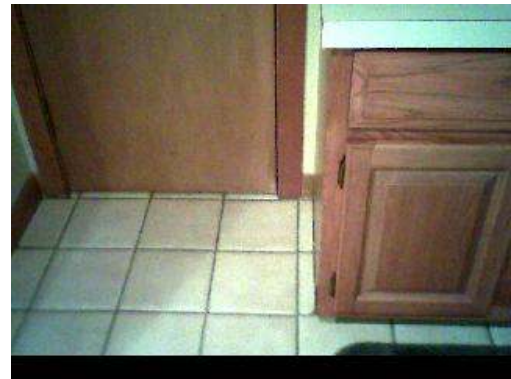
MASTER BATH ATTIC DOOR.IS2

This is the attic access door off of the master bathroom. It shows air infiltration from a poorly gasketed door.

Image Range	30.5°F to 57.8°F
Camera Model	TiR
Camera Serial Number	TiR-08110392
Manufacturer	Fluke
Lens Description	20mm
Image Time	12/04/08 7:21:19 AM

Name	Temperature	Emissivity
Coldest	30.5°F	0.95
P0	54.4°F	0.95

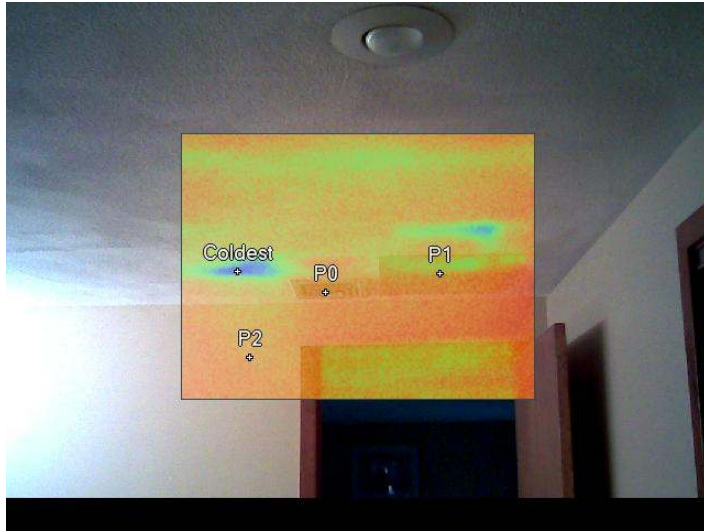
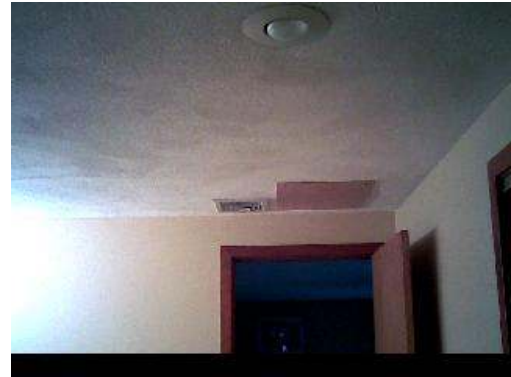
ATTIC OPENING.IS2

Master bathroom attic access opening and HVAC diffuser appear ok but there appears to be an insulation void near the diffuser.

Image Range	51.7°F to 60.0°F
Camera Model	TiR
Camera Serial Number	TiR-08110392
Manufacturer	Fluke
Lens Description	20mm
Image Time	12/04/08 7:28:02 AM

Name	Temperature	Emissivity
Coldest	51.7°F	0.95
P0	58.5°F	0.95
P1	57.7°F	0.95
P2	57.7°F	0.95

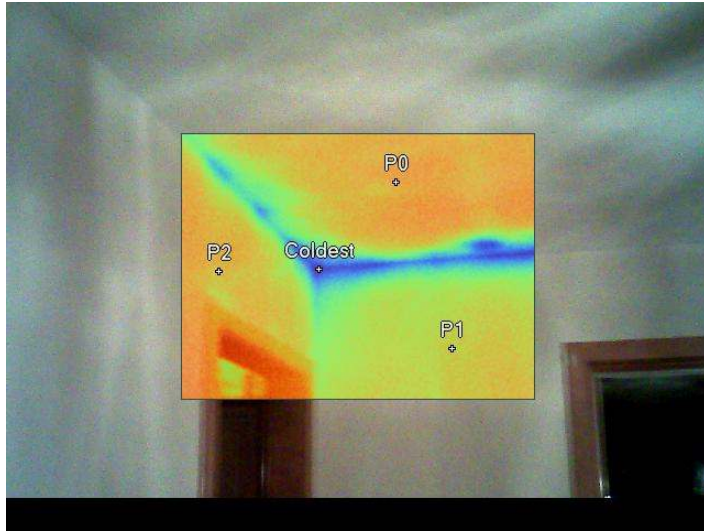
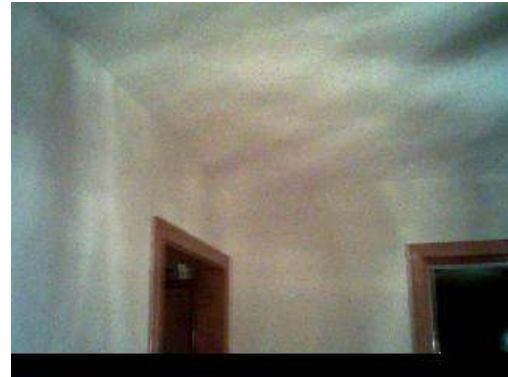
DINING ROOM.IS2

This is the dining room corner adjacent to the kitchen and represents the wall 2x4 "sole" plate.

Image Range	51.6°F to 67.0°F
Camera Model	TiR
Camera Serial Number	TiR-08110392
Manufacturer	Fluke
Lens Description	20mm
Image Time	12/07/08 5:29:20 PM

Name	Temperature	Emissivity
Coldest	51.6°F	0.95
P0	63.6°F	0.95
P1	62.5°F	0.95
P2	63.3°F	0.95
